Internal Degradation Monitoring of Power Devices During Power Cycling Test

Akihiko Watanabe^a, Masahiro Tsukuda^b and Ichiro Omura^a,

^a Kyushu Institute of Technology, 1-1 Sensui-cho, Tobata-ku, Kitakyushu, Japan

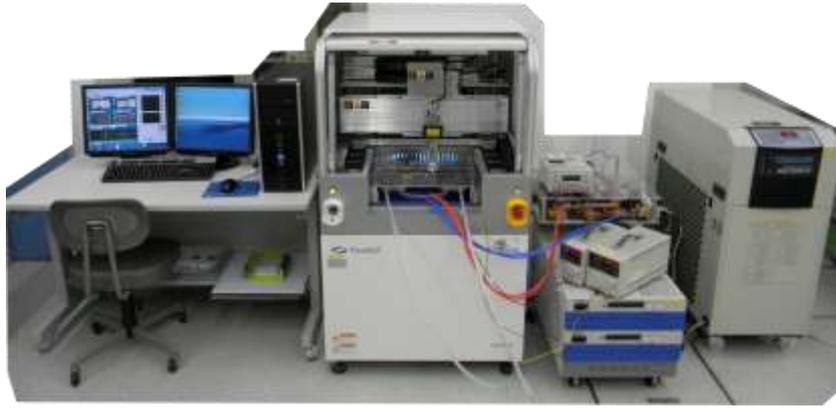
Figure 2 Internal degradation monitoring system

Required components to the real time monitoring of internal phenomena of DUT are (1) non-destructive inside imaging, (2) power stress control and (3) device cooling as shown in Figure 1 and 2.

The temperature of DUT was controlled by using the couplant water. Cooled water from a chiller was lead to a radiator attached at the bottom of the water tank and the radiator cooled down the couplant water in the tank. The cooled water in the tank was flowed to the DUT surfaces with water jet generated by a pump and a jet nozzle to keep the DUT surface temperature. The water jet also suppressed a local convection at the surface by self-heating of DUT which degrade the SAT image. The temperature of the base plate of DUT and that of water in the tank were monitored by fiber optic temperature sensors during the measurement.
