# Characteristics of Lightning Surges Induced in Telecommunication Center in Tropical Area

**Abstract**—The characteristics of lightning-induced surges in telecommunication equipment due to a direct lightning strike at a telecommunication center building or tower should be investigated to maintain the reliability of advanced telecommunication systems. In particular, investigations in tropical areas are important because these areas have many thunderstorm days. We observed lightning surges induced in a telecommunication building in Kuala Lumpur, Malaysia. The results show that the peak value occurrence frequency and waveforms of direct strike lightning surges were almost the same as those in a temperate area. The peak current relationships between the cables in the building and the tower legs indicate a strong correlation between the current at the tower legs, waveguide, power line, and outer and inner conductors of the coaxial cables. However, the peak value correlations between the tower leg currents and interface cable voltages were not strong. Based on the observation results, we obtained the correlation factors between the peak value at the observation point and the tower legs

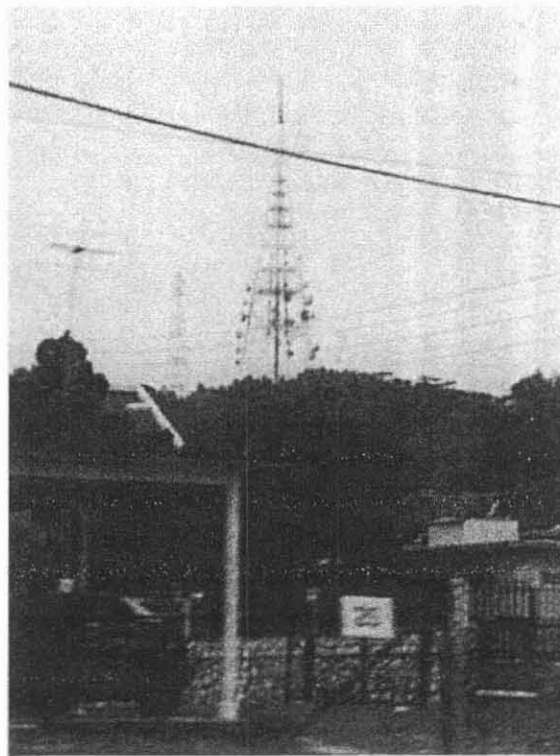
Fig. 1. Observed telecommunication station.

An overview of the tower is shown in Fig. 1. The area surrounding the hill is an almost flat plane and the hill is about 200 m above it. The station has two buildings and a tower (Fig. 2). The main building has four floors and only contains radio-transmission equipment, so no subscriber lines come into it. The tower (height: 120 m) is beside the building. The ac power equipment is installed in the second building, and

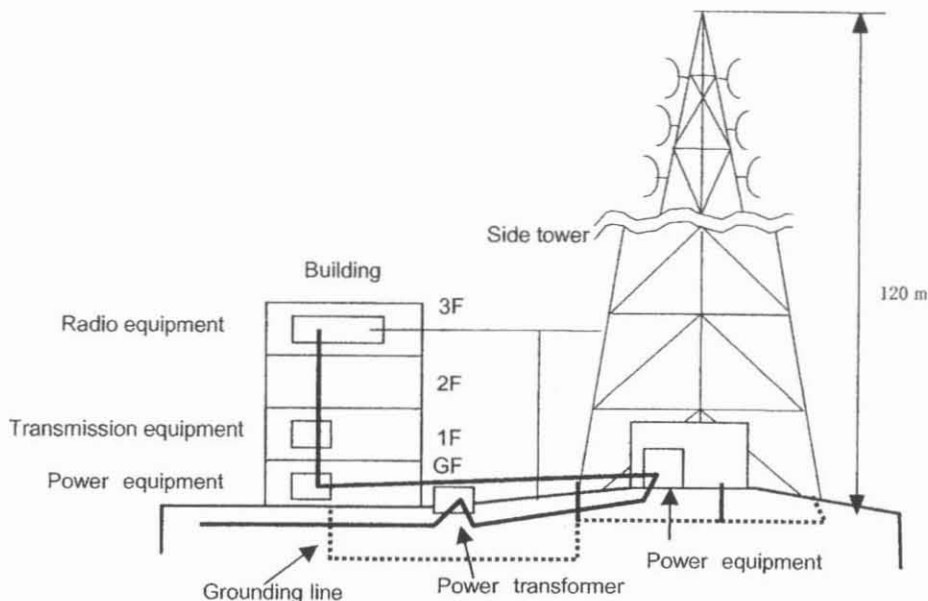
Fig. 2. Configuration of a telecommunication station.

the transformer is set outdoors. All the radio transmission equipment is on the third floor and connected to the antenna on the tower and to the transmitting equipment on the second floor. A grounding line is installed on the tower side of the building. In general, telecommunication towers are placed either on the building's rooftop or beside the building. In this paper, we investigate the surge induced in a building when the tower was located beside the building. The induction mechanism for a building with a rooftop tower is for future study.

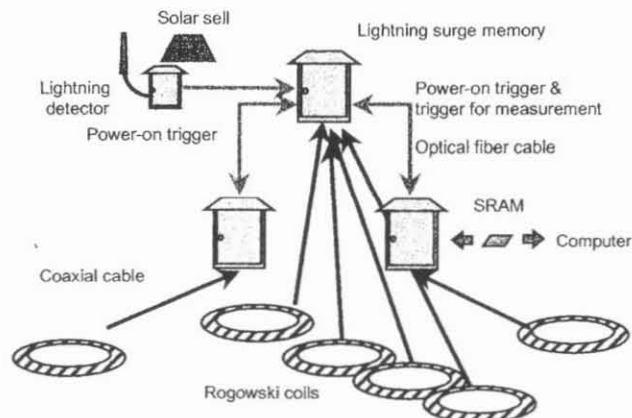
Fig. 3. Configuration of the measurement system (1).

Two systems were used for these observations. One was placed outside the buildings to observe lightning surges appearing at the tower. As shown in Fig. 3, it was composed of a lightning-surge detector, lightning-surge memories, and Rogowski coils [11]. The detector and memories were connected by optical fiber cable to carry the power-on trigger from the detector, which detected the electric field strength of a lightning discharge, to the memories. The detector operated from solar cells and the memories from batteries, so the memories

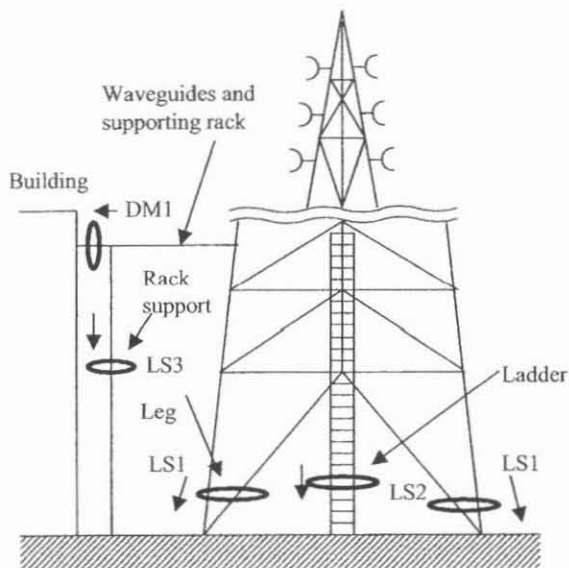
Fig. 6. Observation points at tower.

where  $I_{LS1}$ ,  $I_{LS2}$ ,  $I_{LS3}$ , and  $I_{DM1}$  are the waveforms at each measurement point. This tower has four legs, so we used four Rogowski coils. Their configurations are shown in Figs. 3 and 7. The total surge current in the tower legs was the sum of those in each tower leg; therefore, we connected the four Rogowski coils in series. The waveforms of  $I_{LS1}$ ,  $I_{LS2}$ , and  $I_{LS3}$  were measured using measurement system (1) and the waveform of  $I_{DM1}$  was measured using measurement system (2). The arrows in Fig. 6 indicate the current direction when the measured value was positive.

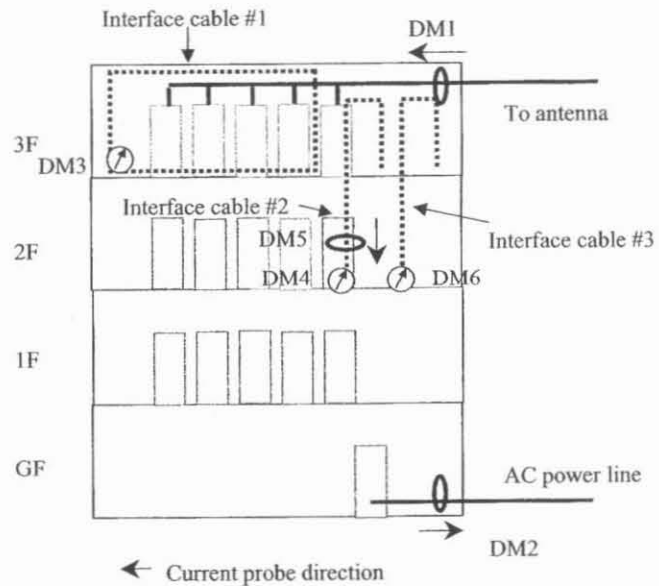
Fig. 8. Observation points in building.

Fig. 8 shows the observation points in the building. The entry points of the waveguide (DM1) and power line (DM2) were measured to investigate the intrusion of lightning surges into the building. At DM1, five waveguides currents were measured with a Rogowski coil using an optical isolation system among the

57 waveguides at the intrusion point. The power-line intrusion point was also measured with a Rogowski coil with an optical isolation system. We also measured the bonding line (DM3), which connected to the waveguides.

We measured the interface cable connecting equipment on the same floor with equipment on another floor. Three additional interface cables were installed on the second and third floors (Fig. 9) for test purposes. Interface cable #1 was installed on the third floor, and interface cables #2 and #3 connected between the third and second floors. Interface cable #1 was a loop wire  $4 \times 8$  m and terminated by  $1 \text{ k}\Omega$  (DM3). A high-impedance probe with an optical isolation system was used for the measurements. This measured the induced voltage at the cable end connecting equipment on the same floor. Interface cable #2 was a coaxial cable whose outer conductor was connected to ground

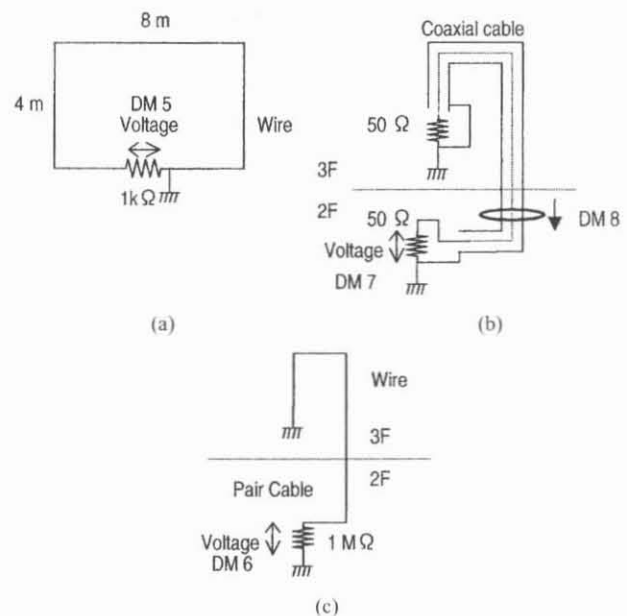
Fig. 9. Configurations of artificial interface cables.

at each floor. Both ends of this cable were terminated by  $50 \Omega$ , which is the characteristic impedance of the cable. It measured the current and voltage induced at the cable end, DM4 and DM5. The optical isolation system was used to measure the voltage and a current probe was used to measure the current. Interface cable #3 was a wire whose third-floor end was connected directly to ground and second-floor end was connected to ground through a  $1\text{-M}\Omega$  resistance at point DM6. A high-impedance probe with an optical isolation system was used for measurement. It measured the voltage potential difference between floors. Measurement system (2) was used for observations at DM1-DM6.

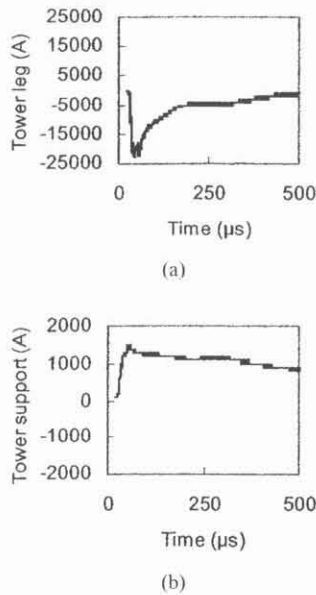
Fig. 10. Lightning-surge waveforms appearing at the tower.

Lightning surges were observed from December 1998 to December 1999. Twenty-two waveforms were observed at tower leg, LS1. Examples of the waveforms are shown in Fig. 10. The currents at the tower legs were negative. This means that the current flowed from ground to the antenna tower as shown in Fig. 6. On the other hand, the current at the supporting rack was positive. This means that the current flowed from the ground to the clouds through the tower.

The peak value, front time, and time to half value of the observed surge are summarized in Table III. Only two waveforms were observed at the supporting rack, and no waveform was observed at the tower ladder (LS2). This caused the trigger levels of LS2 and LS3 to be  $100 \text{ A}$ , which was too large to measure the current at these points although the trigger level was  $1/10$  that of the level at the LS1 point. Therefore, we think that the current at the legs was almost the total current of the direct strike. The average value of the peak value, the front time, and the time to half value at the tower legs were  $32 \text{ kA}$ ,  $10 \mu\text{s}$ , and  $66 \mu\text{s}$ , respectively. These values were close to those observed in a temperate area ( $30 \text{ kA}$ ,  $6 \mu\text{s}$ , and  $75 \mu\text{s}$ ) [3]. 86% of the observed data had

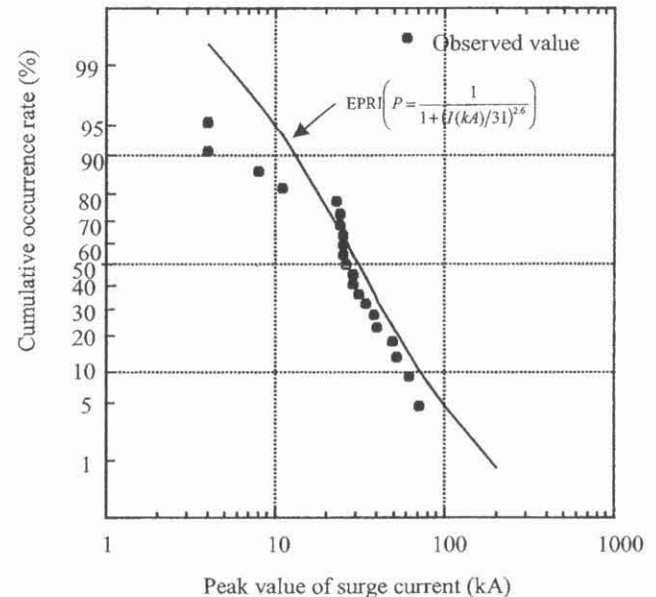
Fig. 11. Cumulative-occurrence frequency of direct stroke lightning-surge peak current.

The cumulative-occurrence frequency of the peak value is shown in Fig. 11. The solid line indicates the peak value cumulative occurrence frequency in a temperate area [12]. Fig. 11 shows that the occurrence frequency of the observed data almost

agrees with data for a temperate area, but the observed data deviated from the solid line when the peak value was less than 10 kA. This may be because the trigger level of the observation equipment was small, so we eliminated this data. From these results, we can conclude that the cumulative occurrence frequency of direct strike lightning-surge current in a tropical area agrees well with that in a temperate area.

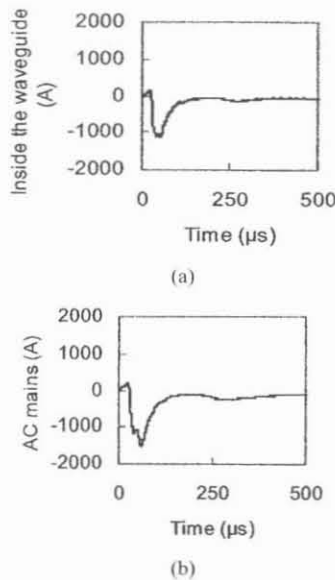
Fig. 12. Surge current waveforms appearing at (a) wave guide (b) and power line.

The lightning-surge current at the waveguide (DM1 in Fig. 4) and power line (DM2) were observed. The relationships between the waveforms at DM1, DM2, and the tower legs were identified from the observation time. We obtained 44 and 51 waveforms, respectively. Examples of these are shown in Fig. 12. The surges were generated by a surge current at the tower legs, as shown in Fig. 10. These figures indicate the similar waveforms observed at the waveguide and power line in this building.

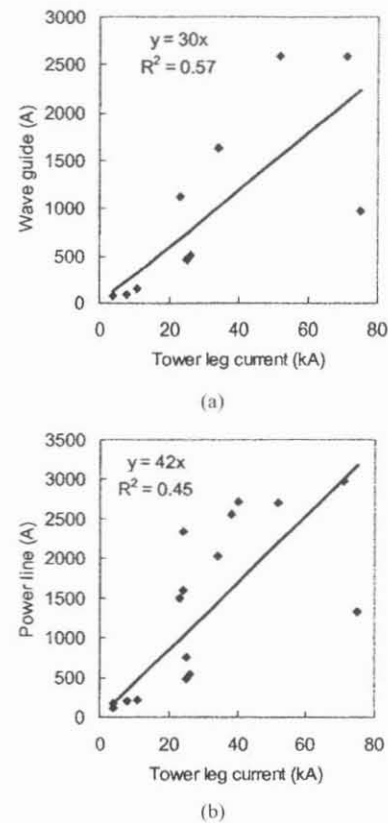
Fig. 13. Relations between building intrusion points and tower legs.

The relationships between the peak values at the building intrusion points and the tower legs are shown in Fig. 13. The solid lines in these figures are recursive lines. The relationships are almost linear, and the correlation factor is more than 0.6. This means that the peak values of the current do have a correlation. These figures show that the peak value at the waveguide was 0.03 times that at the tower legs; five out of 57 waveguides were measured, so this corresponds to 0.34 times for all the waveguides, and the peak value at the power line was 0.042 times that at the tower legs.

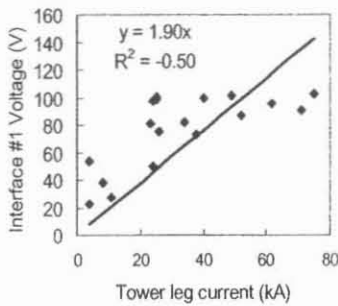
Fig. 15. Relation between voltage at interface cable #1 and tower legs current.

The relationships between peak values at interface cable #1 and the tower legs are shown in Fig. 15. The solid line in this figure represents the recursive equations shown in Fig. 15. We did not obtain a strong correlation between the current at the tower legs and interface cable #1. This means that the waveform at the tower legs influenced the peak value at cable #1 because the coupling was mainly capacitive and inductive coupling. Although the correlation was weak, Fig. 15 shows that the peak value at cable #1 had a trend 0.0019 times that at the tower legs.

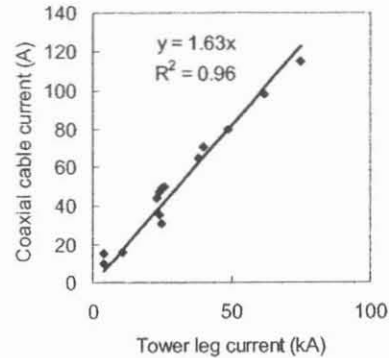
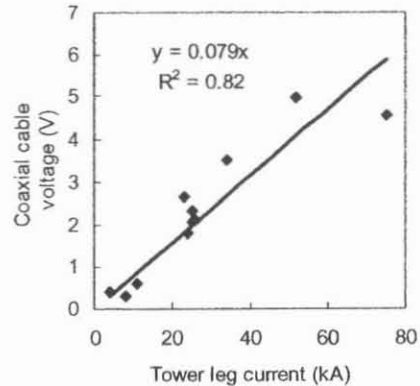
Fig. 17. Relations between interface cable #2 and tower legs.

The relationships between peak values at interface cable #2 and the tower legs are shown in Fig. 17. The solid lines are the indicated recursive equations. The correlation factor of the current shown in Fig. 17(a) is more than 0.9, so good correlation was obtained. The peak value at the outer conductor of cable #2 was 0.0016 times that at the tower legs. And the correlation factor of the voltage shown in Fig. 17(b) was more than 0.8, so good correlation was obtained. The peak value at the inner conductor of cable #2 was 0.000 079 times that at the tower legs.

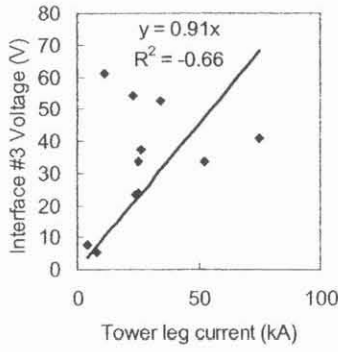
Fig. 19. Relation between voltage at interface cable #3 and tower leg current.

The relationships between peak values at interface cable #3 and the tower legs are shown in Fig. 19. The solid line is the indicated recursive equations. As with cable #1, strong correlation was not obtained between the current at the tower legs and interface cable #3. This means that the waveform at the tower legs influenced the peak value at cable #3 because the coupling was

mainly capacitive and inductive coupling. Although the correlation was weak, Fig. 19 shows that the peak value at cable #3 had a trend 0.0009 times that at the tower legs.

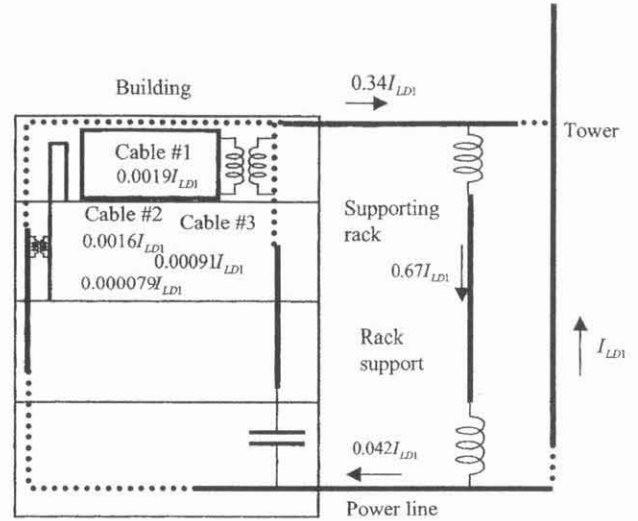
Fig. 20. Relationship between tower legs current and other observation points.

The relationships between the peak value among the tower legs and the observation points (obtained from Figs. 10, 13, 15, 17, and 19) are summarized in Fig. 20. The dotted line indicates that the coupling might be conductive, which is usual when the waveform at the observation point is similar to that at the tower legs as shown in Figs. 10 and 12. The conductive coupling with self-inductance is represented by an inductor and it is estimated when the front time and time to half value are longer than those at the tower legs, as shown in Fig. 10. The inductive and capacitive coupling is represented by a capacitor and transformer. This is estimated when the front time and time to half value are shorter than those at the tower legs, as shown in Fig. 10. Cables #1 and #3 were isolated from the ground, as shown in Fig. 9. This is why the coupling was mainly capacitive and inductive coupling in these cables.

It is important to obtain the occurrence probability of the lighting surge current and voltage caused by direct strikes. From our investigation, we obtained the relationships between the direct strike current and interface cable shown in Fig. 20. Here, we calculate the occurrence probability of the peak value.

where  $F_N$  is the relationship shown in Fig. 20.

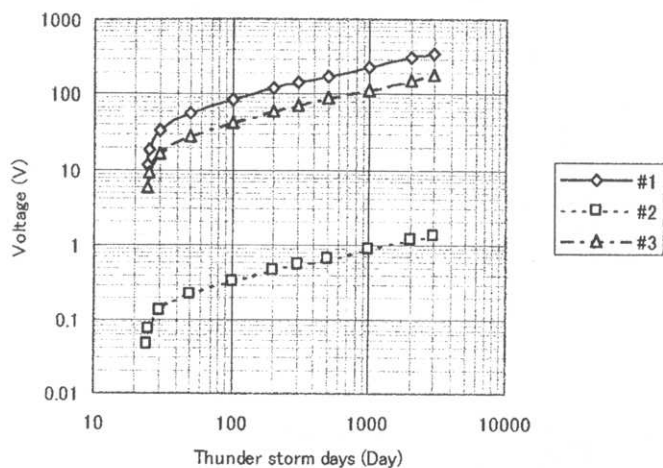
Fig. 21. Occurrence probability of lightning surge at interface cable.

Calculation examples are shown in Fig. 21. The horizontal axis is the number of thunderstorm days and the vertical axis is the peak value. Fig. 21 shows that a peak value of 300 V might appear at the interface cable end (cable #1) during a 10-year period because there are 200 thunderstorm days per year in the observation area.
